2 Model 6922NB

## SERVICE CHANGE

1. Change on Gear and Gear Housing.

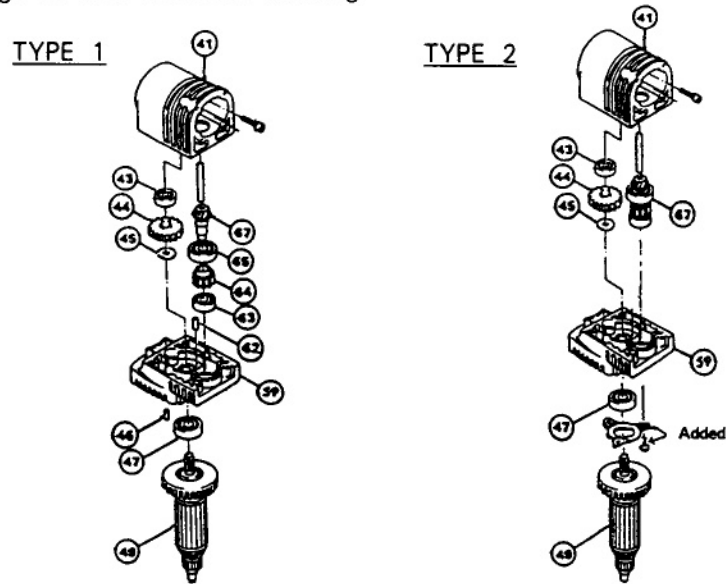
The above parts are interchangeable as a set.
